Manhole Inspection Summary

Manhole # S27EE_008MH

Insp Date: **3/18/08 9:59 AM**

Location Address: **502 LAFFAYETTE AV**

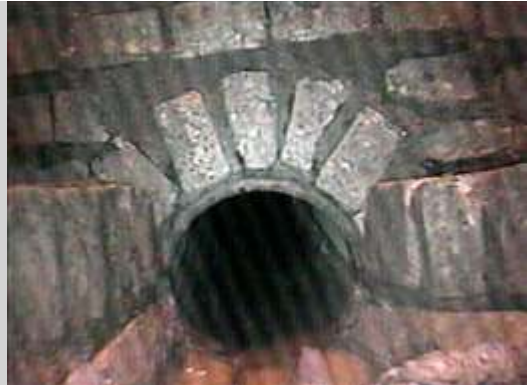
12 O'Clock Outflow

8 in. Circular Gravity Sewer
Pipe Out @ 12 O'Clock

Pipe Material: **Clay** ☐ Pipe Lined

Invert Depth: **9.93** (ft.) Flow Characteristics: **Slow**

Infiltration: **None** Pipe Seal Cond: **Cracked**

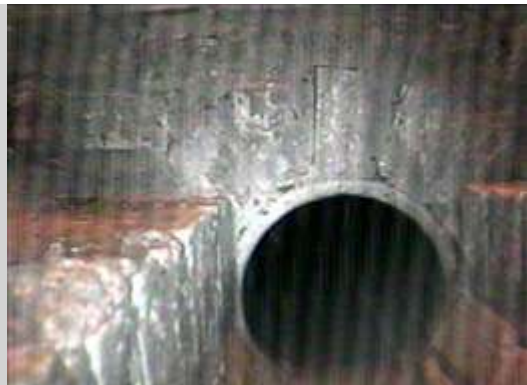
3 O'Clock Inflow

8 in. Circular Gravity Sewer
Pipe In @ 3 O'Clock

Pipe Material: **Clay** ☐ Pipe Lined

Invert Depth: **9.56** (ft.) Flow Characteristics: **Slow**

Infiltration: **None** Pipe Seal Cond: **Sound**

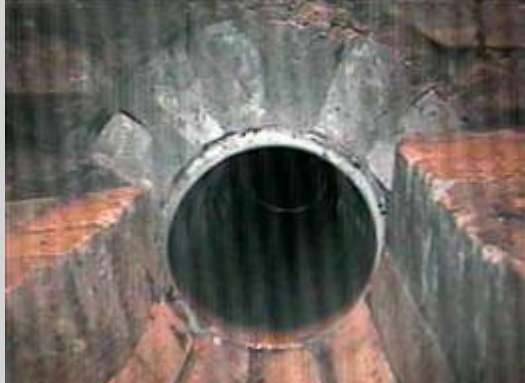
6 O'Clock Inflow

8 in. Circular Gravity Sewer

Pipe In @ 6 O'Clock

Pipe Material: **Clay** ☐ Pipe Lined

Invert Depth: **9.66** (ft.) Flow Characteristics: **Slow**

Infiltration: **None** Pipe Seal Cond: **Sound**

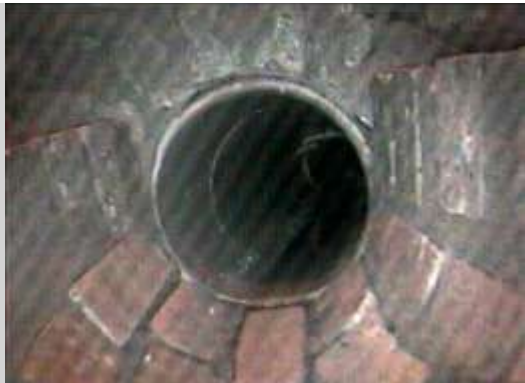
9 O'Clock Inflow

8 in. Circular Gravity Sewer

Pipe In @ 9 O'Clock

Pipe Material: **Clay** ☐ Pipe Lined

Invert Depth: **9.63** (ft.) Flow Characteristics: **Slow**

Infiltration: **None** Pipe Seal Cond: **Sound**
